FIRST NATIONS MOLD REMEDIATION CASE STUDY

Ahousaht First Nation

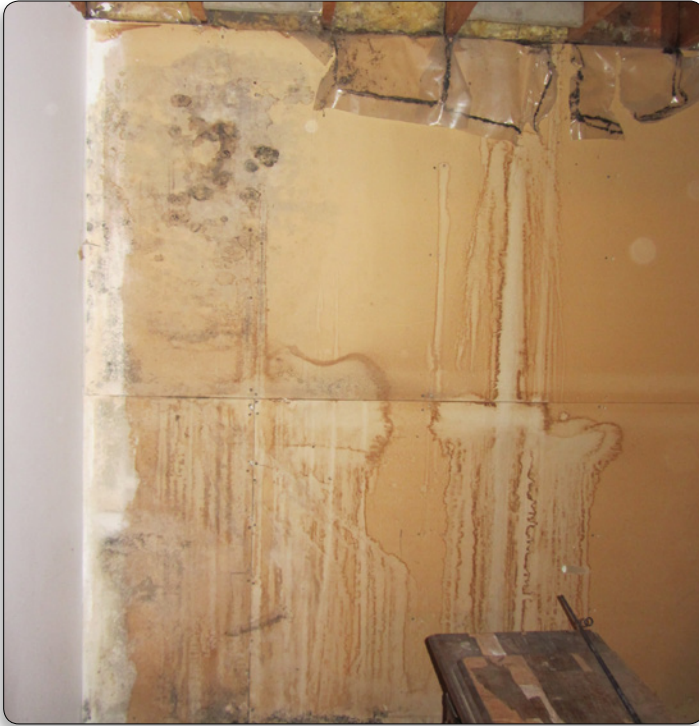
Figure 2 The interior wall shows moisture damage originating in the porch attachment, shown below in figure 3

Overcrowding, substandard building practices, poor workmanship, inadequate or no drainage systems, no formal process for building code inspections, low-cost moisture susceptible building materials and the harsh, wet, west coast weather are some of the factors that have caused the accelerated deterioration of the houses, high moisture problems and mold (see figures 2 and 3).

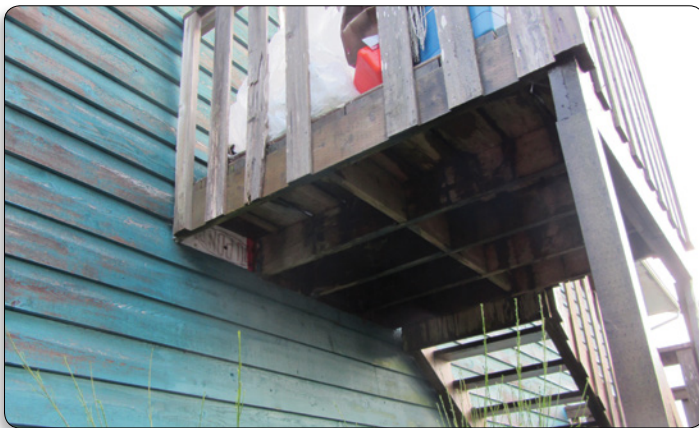
Figure 3 Porch attachment. View from outside

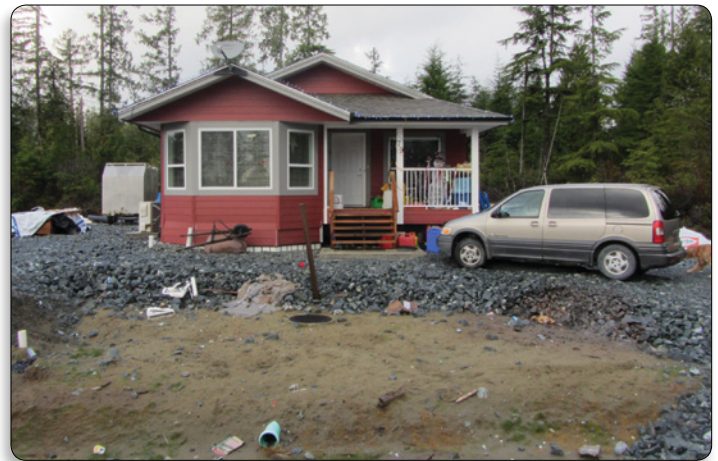
Figure 4 New house on gravel pad to drain water away from the house

The island's old quarry was put back into service to generate stone and granular fill to build roads, driveways and gravel pads used to create well-drained home sites. With the help of a crusher and screening plant, various granular fill materials were created, ranging from 19 mm (0.75 in.) to 15 cm (6 in.). Once servicing of the lots was completed, gravel pads were placed to a depth of 1 metre (3 feet)—raising each house away from the water table and creating a significant drainage layer (see figures 4 and 5).

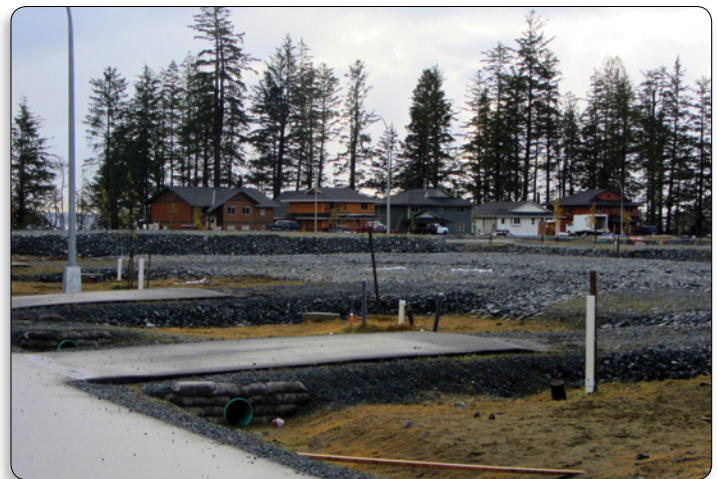
Figure 5 New subdivision showing roads, street lights, services and gravel pads

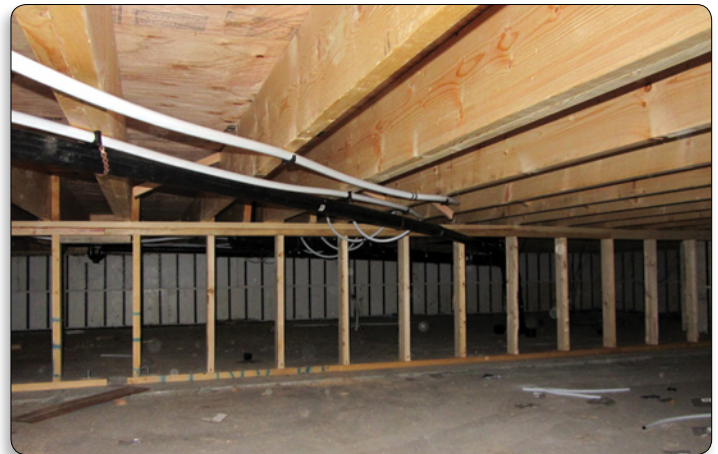
Figure 6 ICF crawl space on concrete slab provides a dry and warm space

The ICF walls and the concrete slab ensure that crawl spaces are dry and warm (see figure 6). Concrete was provided by means of a small batch plant located in one corner of the subdivision (see figure 7).

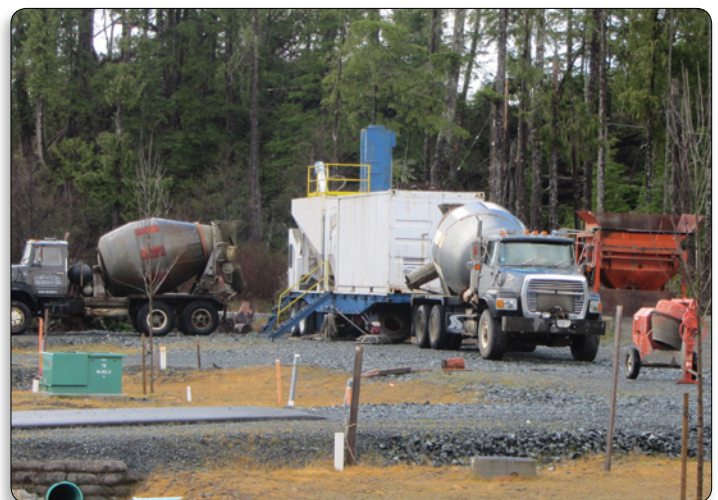
Figure 7 On-site concrete plant to service the construction of the new subdivision

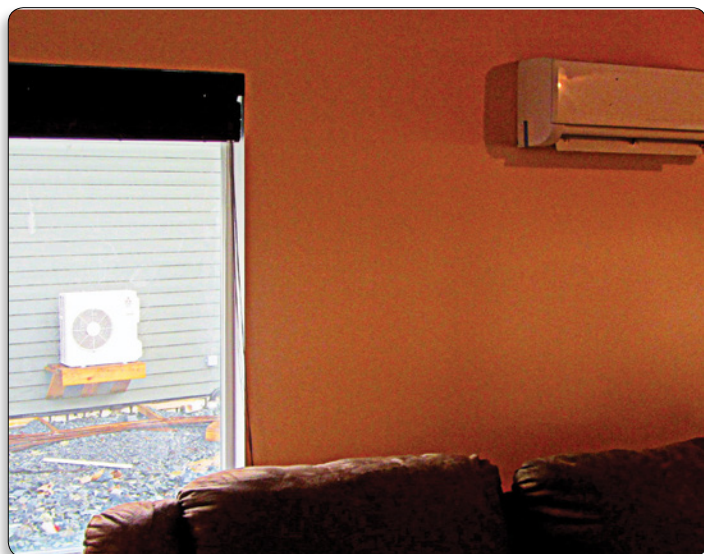
Figure 8 Mini-split heat pump—the view out the window shows the outdoor compressor unit on the adjacent house

In addition, with the installation of the mini-split heat pumps, these new homes now heat for a fraction of the cost of using electric baseboards. It is worth noting that the mini-split heat pumps also have the ability to function as dehumidifiers to ensure that appropriate moisture levels are maintained in the homes—this is especially important in a mild, wet climate like that found on the west coast. That said, electric baseboard heaters are still used but only to provide backup heat and even out the temperatures in the bedrooms that the mini-splits do not directly serve (see figure 8).

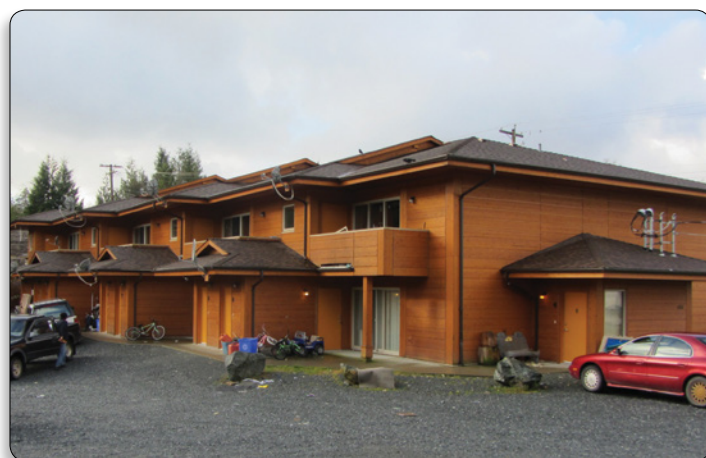
Figure 9 Newly built eight-unit complex showing new design options

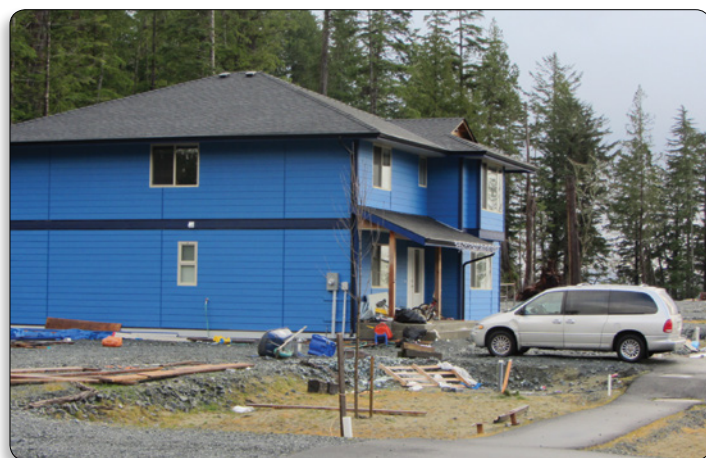
Figure 10 Newly constructed house showing new building practices

Because of limitations with available power, only 14 new houses are built per year. If this number is repeated in coming years there will be a steady and predictable number of new homes in the community. The new houses look and perform differently than anything ever built in the community, as evidenced by a new eight-unit complex (see figure 9). An early indication of the building's performance success is demonstrated by the evidence of moisture problem-free homes. This was accomplished through newly adopted design features; ventilation and air movement combined with a drainage system that sheds water away from the house. It is obvious just driving around the subdivision that something new is happening in housing (see figure 10).

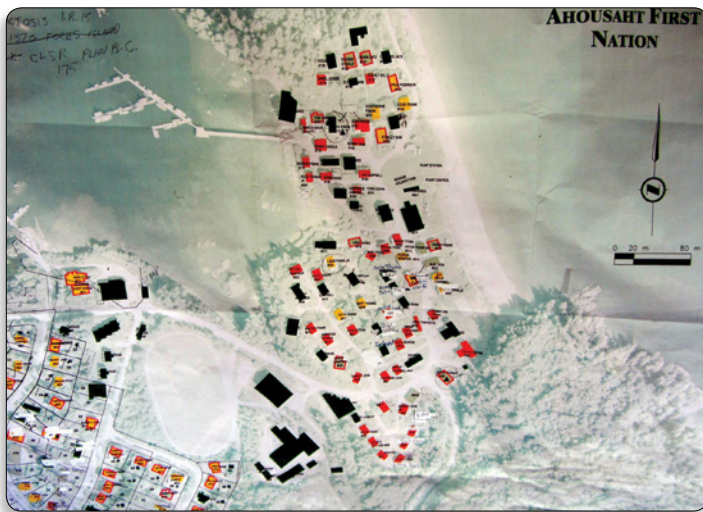
Figure 11 Colour-coded map of the community, showing the priorities for mold renovations based on occupants’ health concerns and amount of mold in the home

To better understand the challenges facing the community, the Housing Department, with assistance from the Health Canada environmental health officer (EHO), created a colour-coded map of the community, which was used to create a priority list for mold renovations (see figure 11).

Priority was based on the occupants’ health concerns and the amount of mold in the home. A maximum of \$65,000 was budgeted for repairs and mold remediation.
